USAAVLABS TECHNICAL REPORT 68-65

**ADVANCEMENT OF HIGH-TEMPERATURE TURBINE
TECHNOLOGY FOR SMALL GAS TURBINE ENGINES**

FLUID-COOLED AXIAL FLOW TURBINE

**CONTINENTAL AVIATION AND ENGINEERING CORPORATION
DETROIT, MICHIGAN**

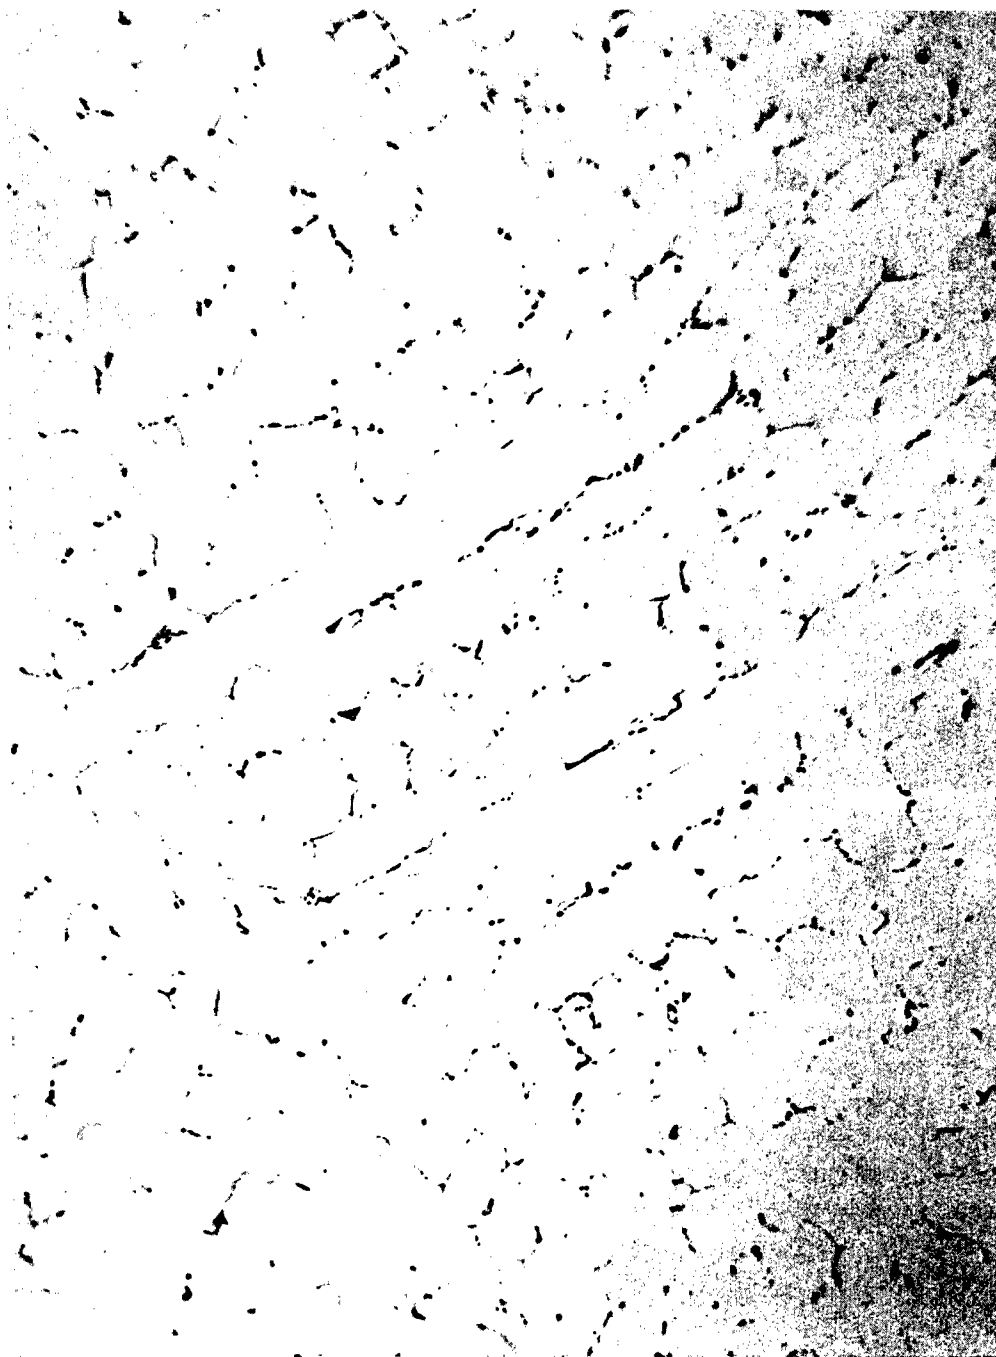
Figure 79. Typical Microstructure of Cast Rectangular Blade.

In addition to surface requirements, certain metallurgical quality standards were imposed; namely, grain size ($1/16$ to $3/16$ inch with no columnar grains in the simulated airfoil) and no internal shrinkage or porosity. Figures 78 and 79 show that these conditions were obtained in the sample sections shown.

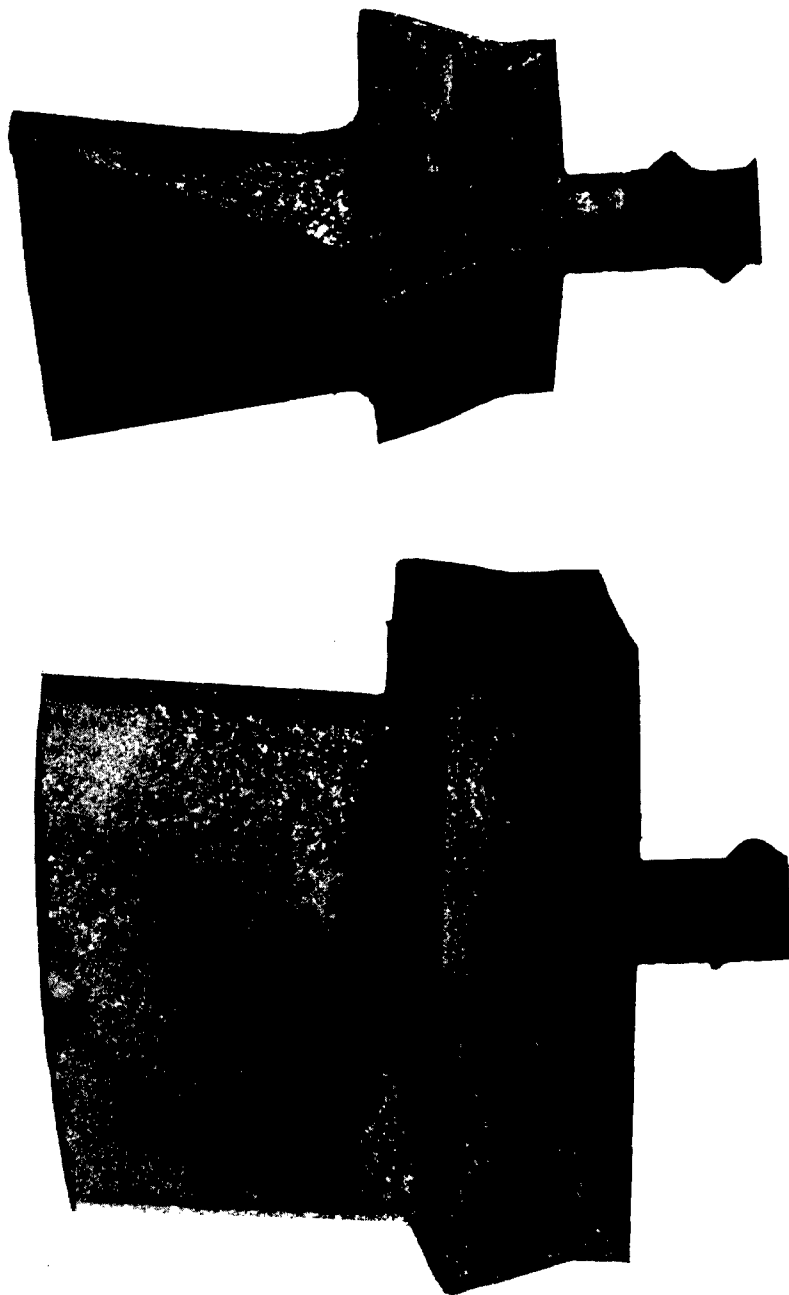
Figure 88. Cast Cooled Blade Etched to Show Equiaxed Surface Grain and Columnar Internal Grain Where Ingate Was Cut Off.

The surface of the cast blade revealed an equiaxed grain structure having a grain size less than 1/8-inch diameter maximum with an average of less than 1/16-inch diameter. The internal grain structure examined at the junction of the ingate and the blade root was found to be columnar, as shown in Figure 88. This examination indicated that the grain size requirement was met.

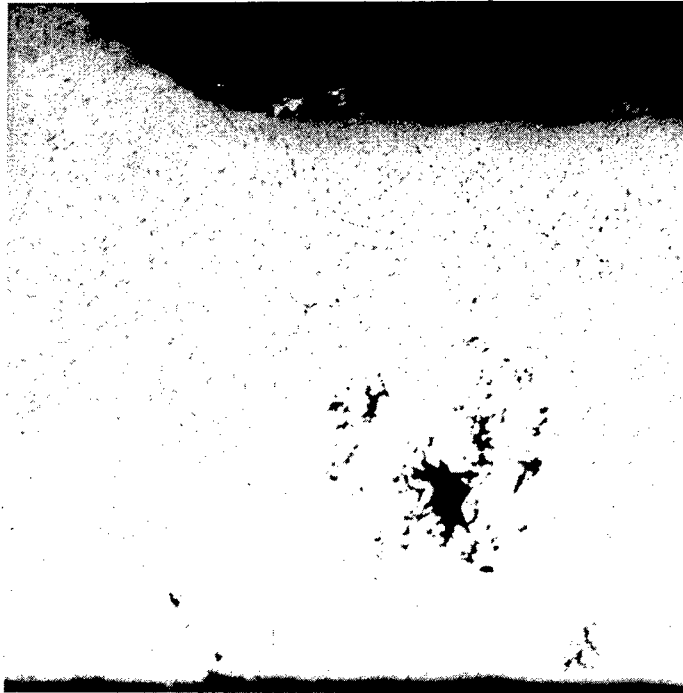
Figure 93. Shrink Defects in Heat Exchanger.

The casting was sectioned in several areas to examine the general internal microstructure and for evidence of microporosity. These sections are shown in Figures 90 through 93. A porous shrink condition shown in Figures 92 and 93 was found in the heat exchanger shank. This type of defect could interfere with welding operations and general strength requirements and is prohibited by the X-ray requirements of the specification. However, the defect is not readily detected in the radiograph so that a destructive spot check must be relied upon, together with casting process improvements, to eliminate the defect.

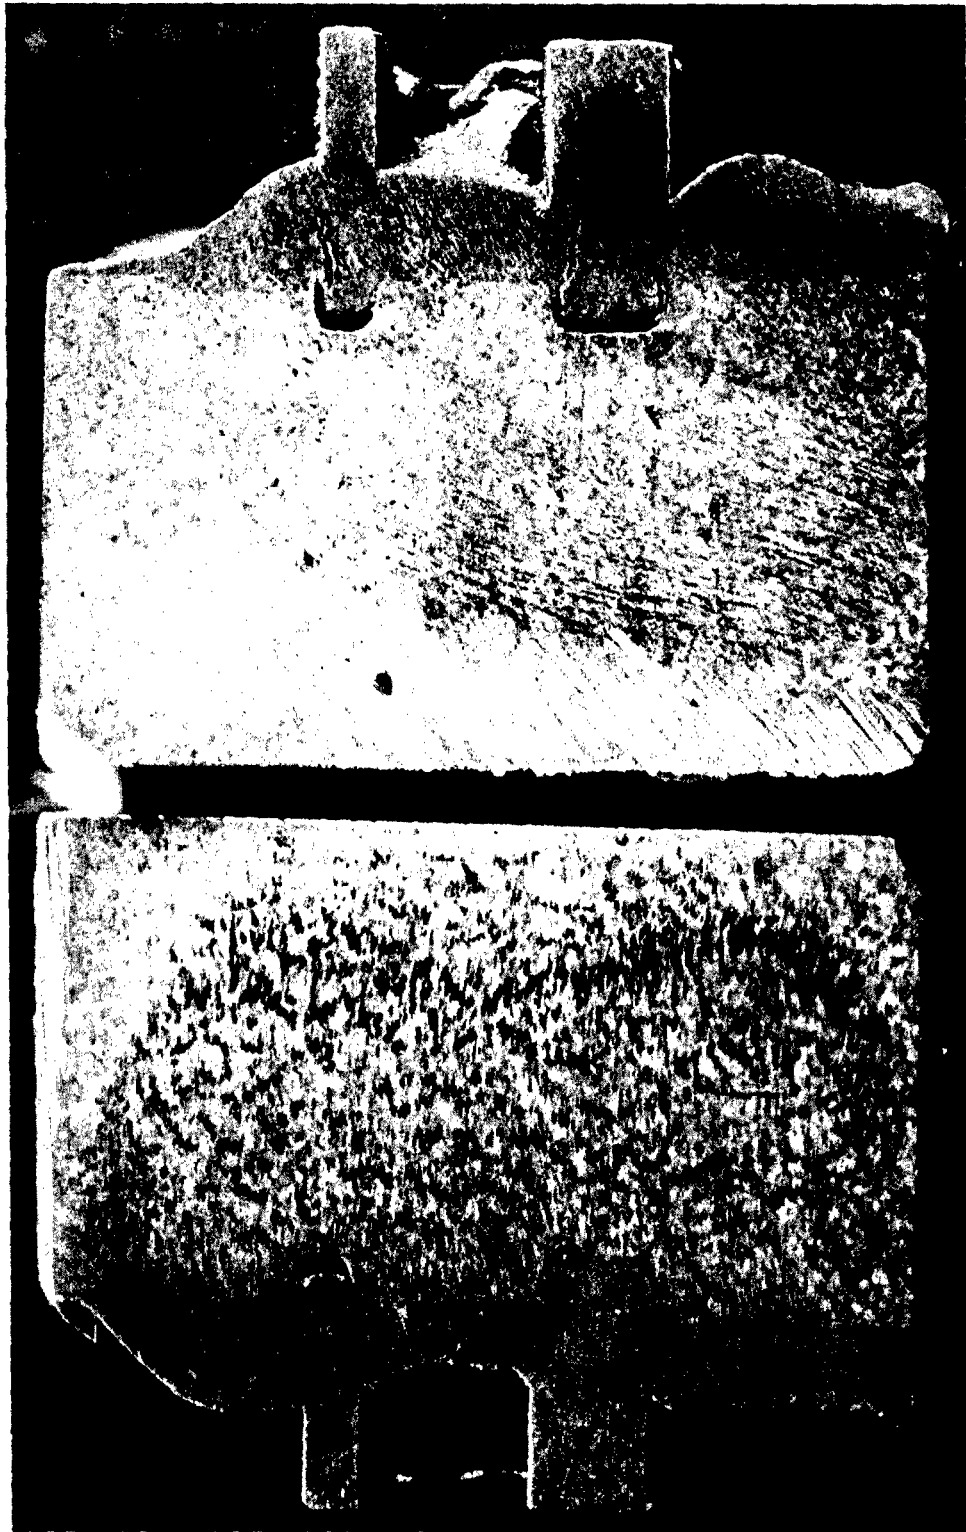
Figure 103. Cross Section of Tip-Cap Weld - Beam Focus at Cap Edge.

The above results are demonstrated, using 140 KV, 16.5 MA at a rate of 45 inches per minute (see Figures 103 and 104).

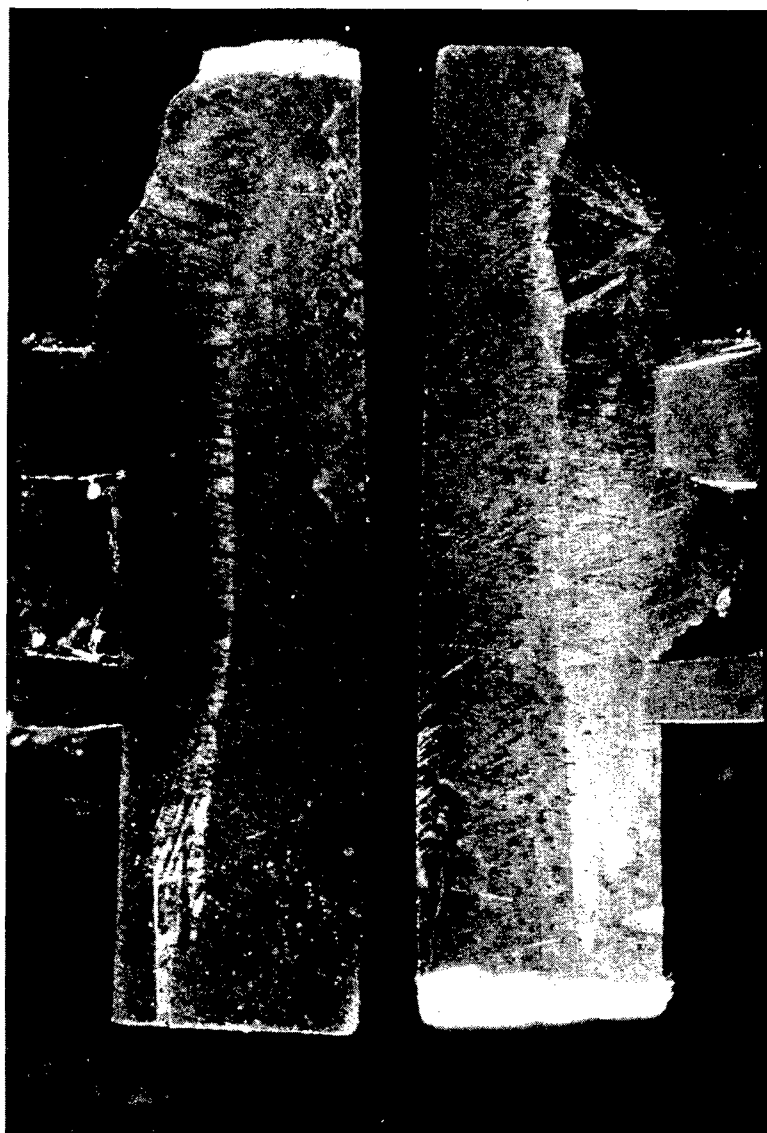
Figure 104. Cross Section of Tip-Cap - Beam Focus 0.030
Inch From Cap Edge.

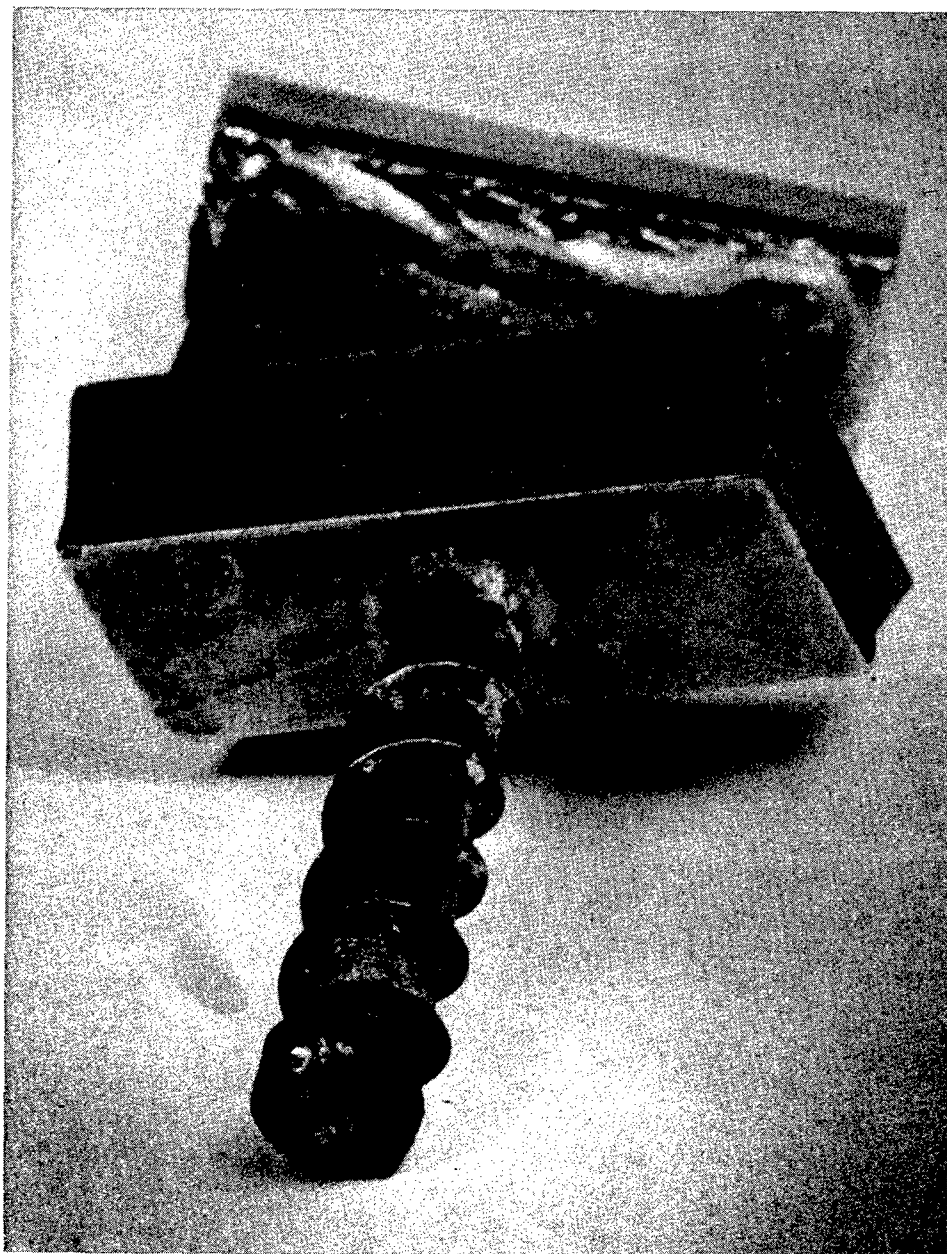
Figure 112. TIG Welded Heat Plug in Airfoil Blade.

This technique was repeated with a second blade casting with similar results. Figure 112 shows the results of these efforts.

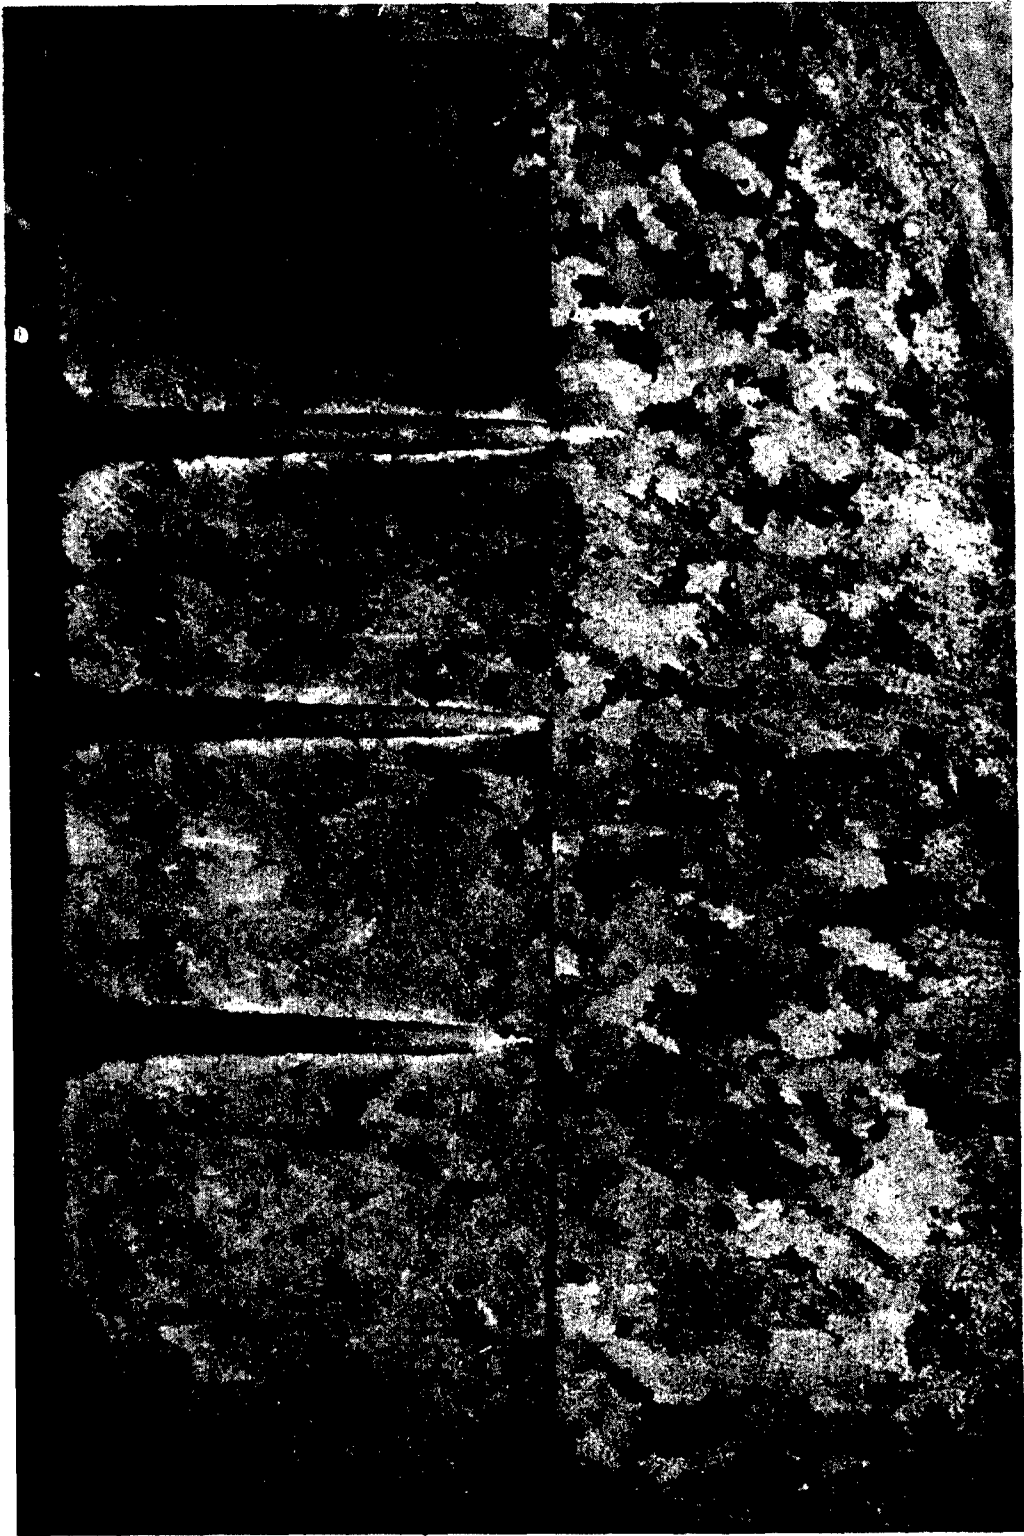
Figure 119. Parameter Test Block, Hamilton Standard Welder.

Figure 119 is typical of the test block by another vendor to establish these conditions using Hamilton Standard equipment. Typical settings for this equipment are as follows:

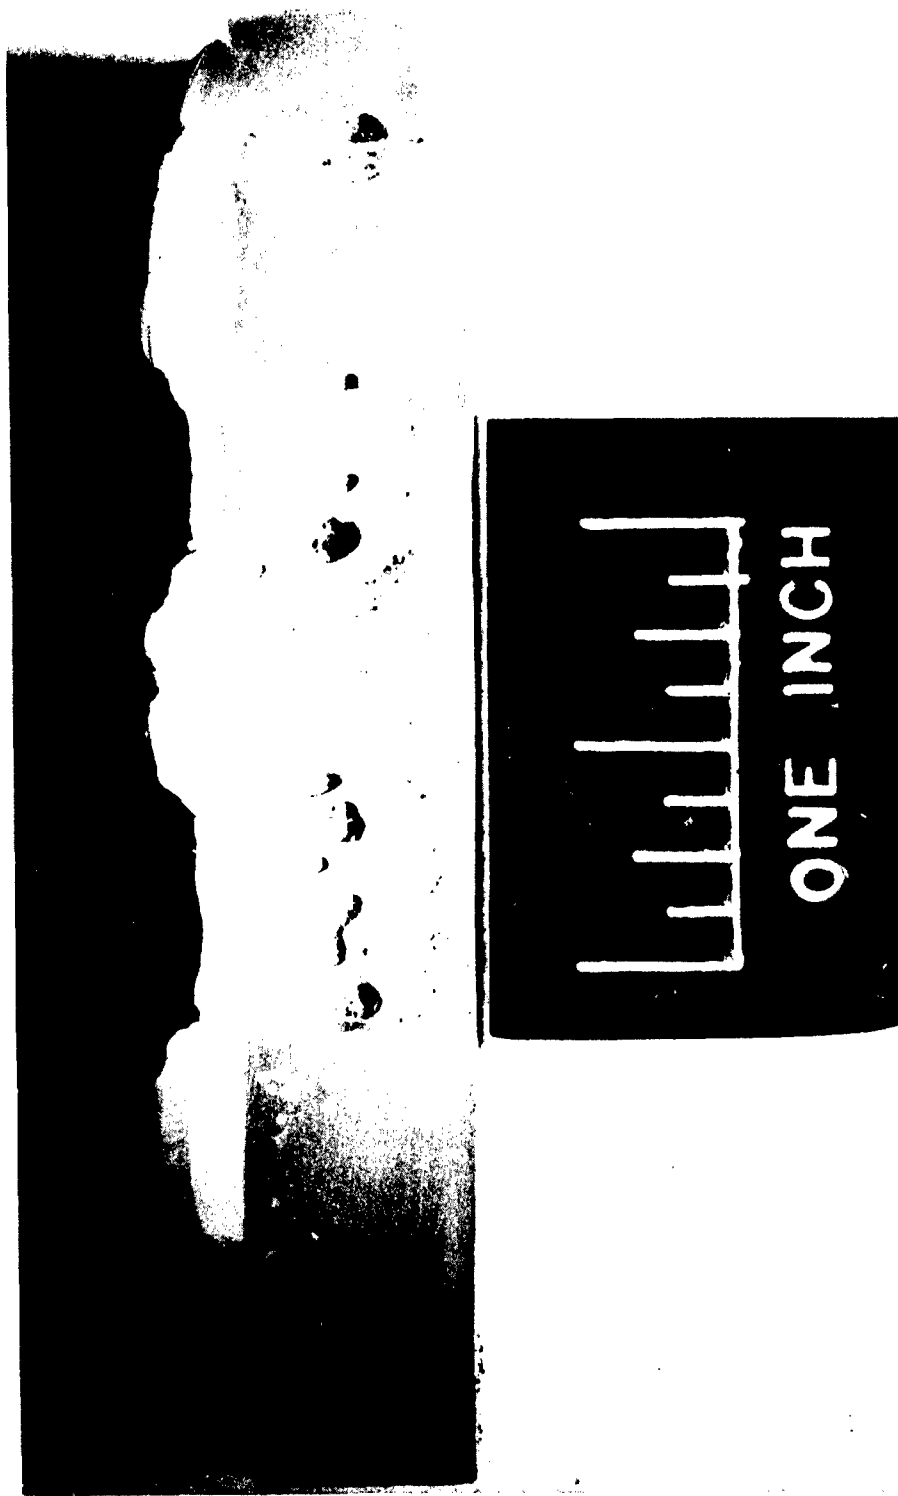
Figure 124. Penetration Variation When Welding Over Copper Bars.

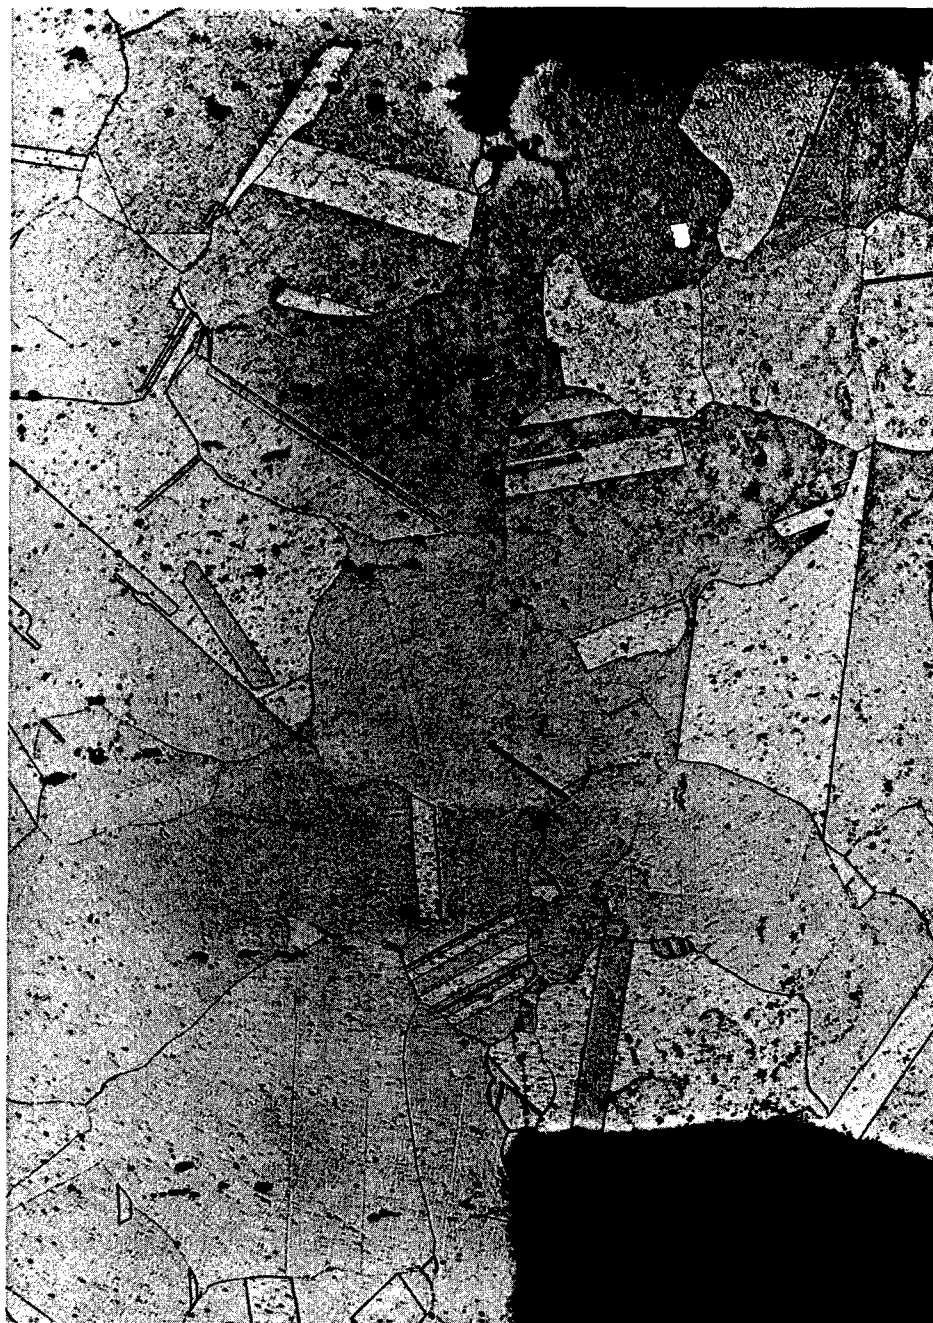
Figure 146. Photomicrograph of Sample Pressed 4 Hours at 1850° F Followed by 2 Hours at 2150° F.

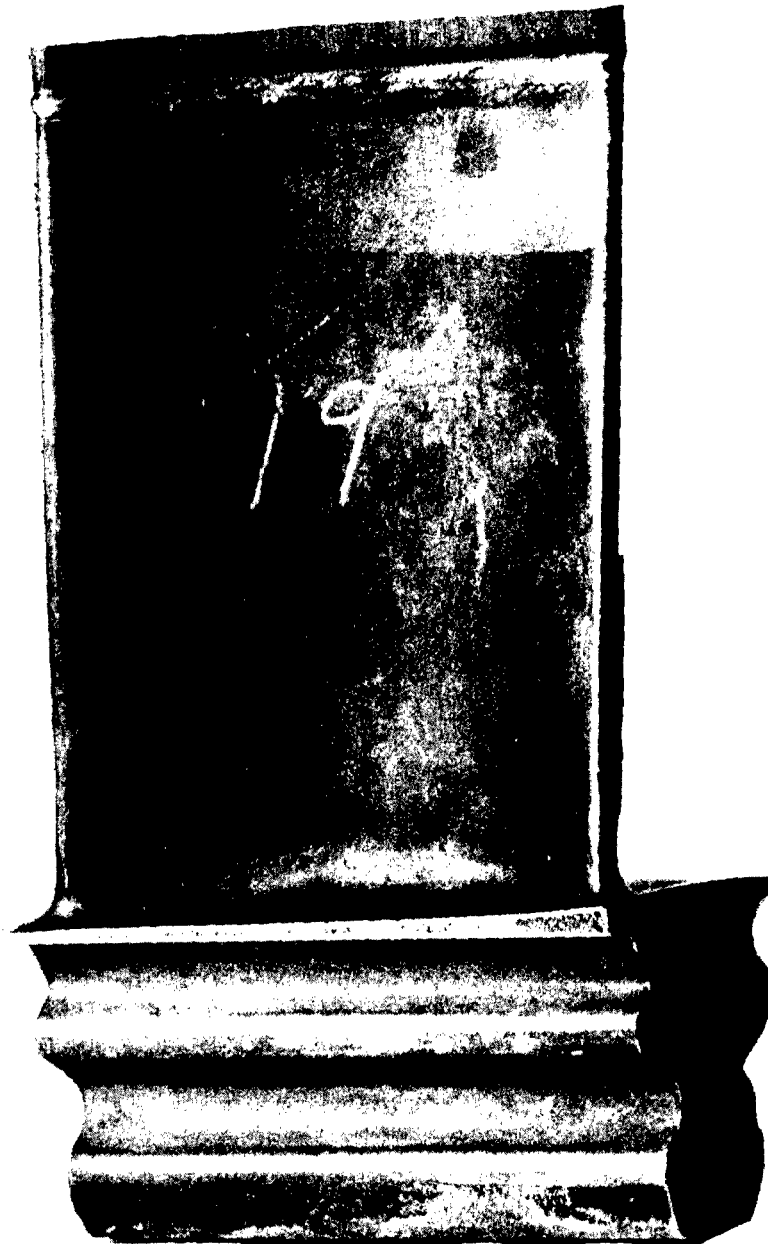
Figure 150. Fluid-Cooled Blade - Electron Beam Welded.

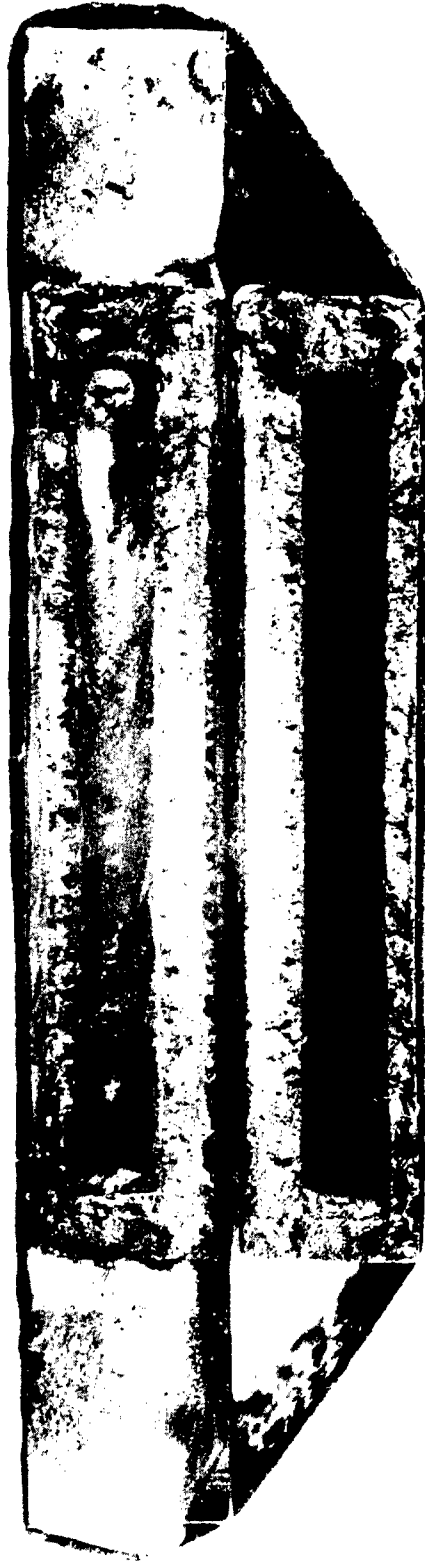
Figure 158. Typical Fatigue Fracture of Rectangular Blade.

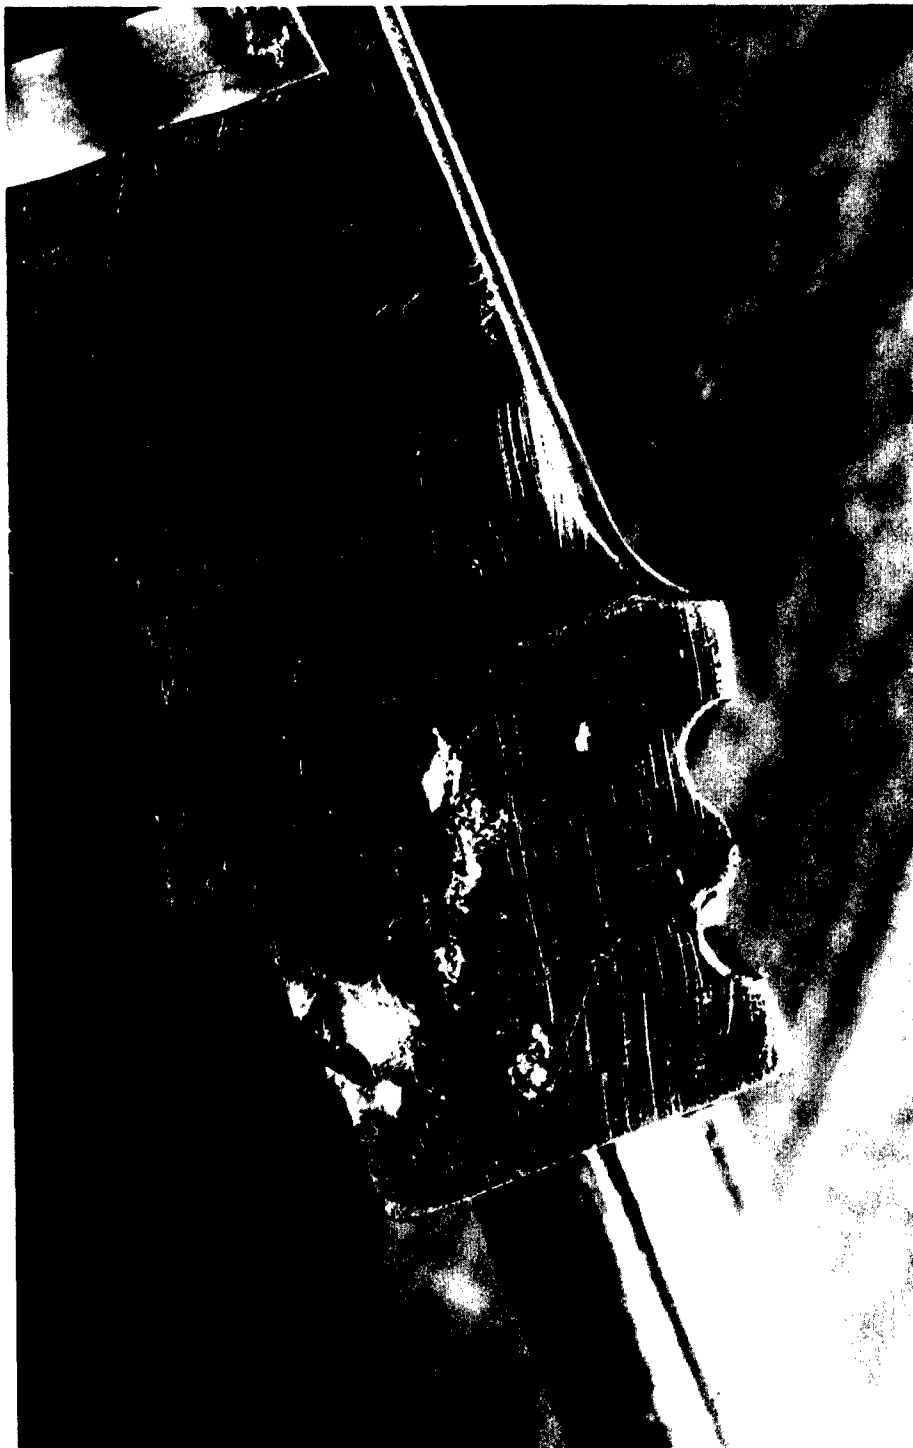
Figure 222. Blade Attachment - Test Specimen.

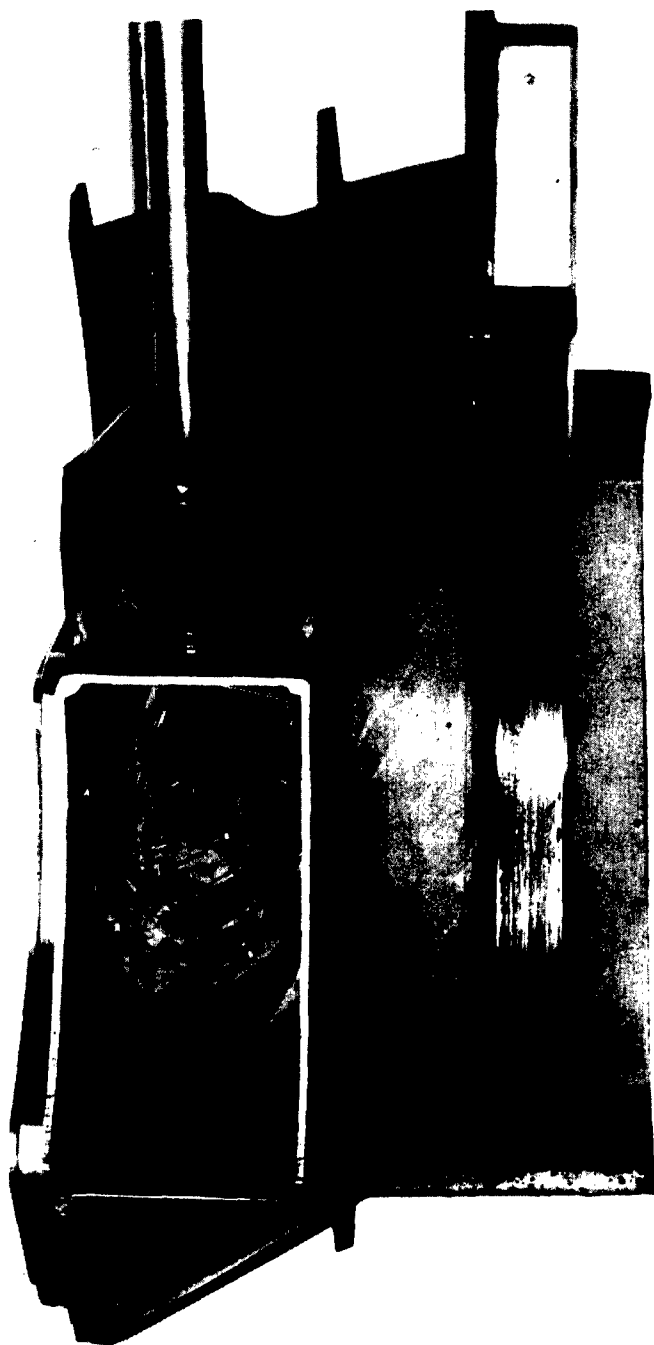
Figure 265. View of Inner Shroud Showing Vane and Shroud Instrumentation.

The vane and shroud metal temperatures were measured with Inconel sheathed, magnesium oxide insulated, chromel-alumel thermocouples welded in place and insulated with a ceramic cement. Figures 265 and 266 show this instrumentation installed; identification of the individual thermocouples is shown schematically on the vane profile and shroud sketches of Figures 267 through 269.

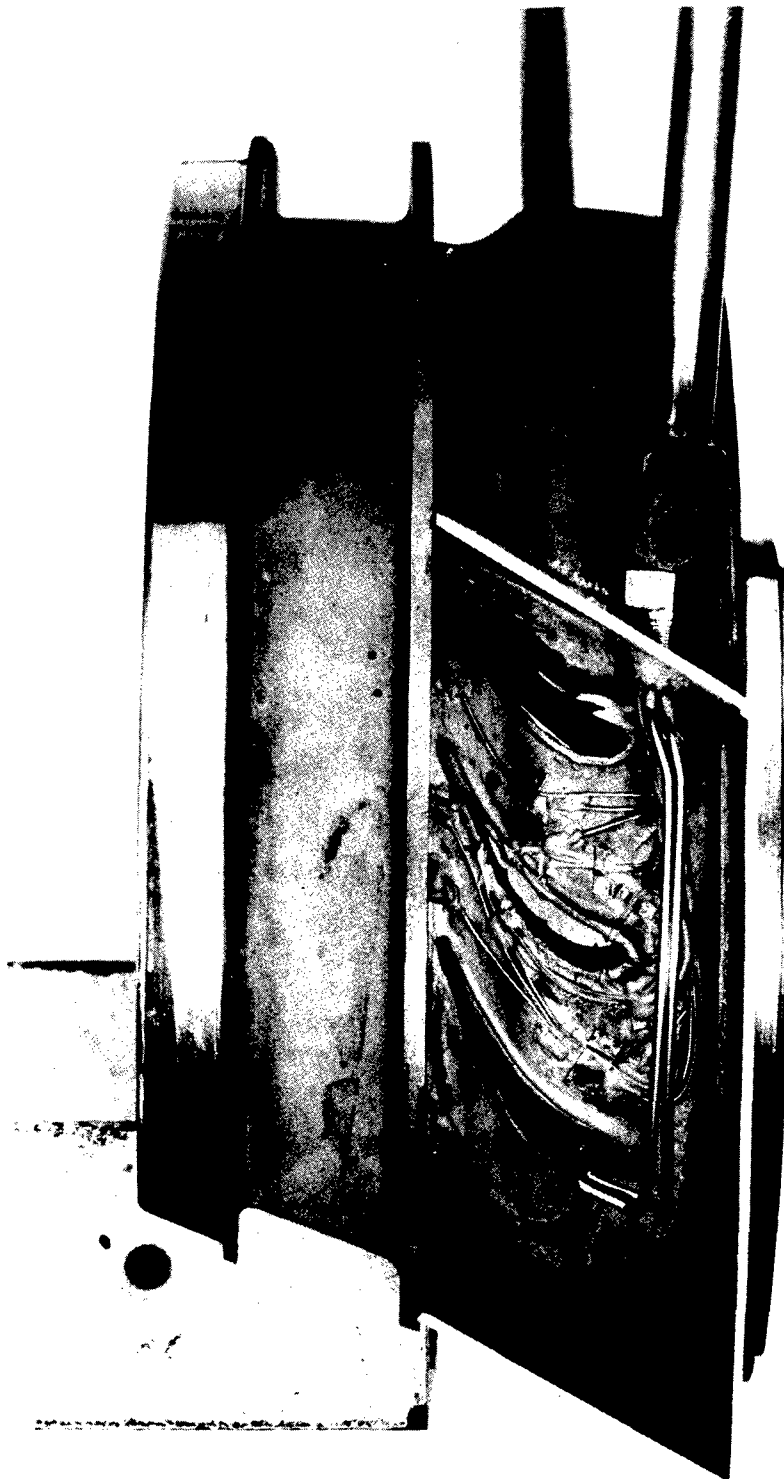
Figure 266. View of Outer Shroud Showing Vane and Shroud Instrumentation.

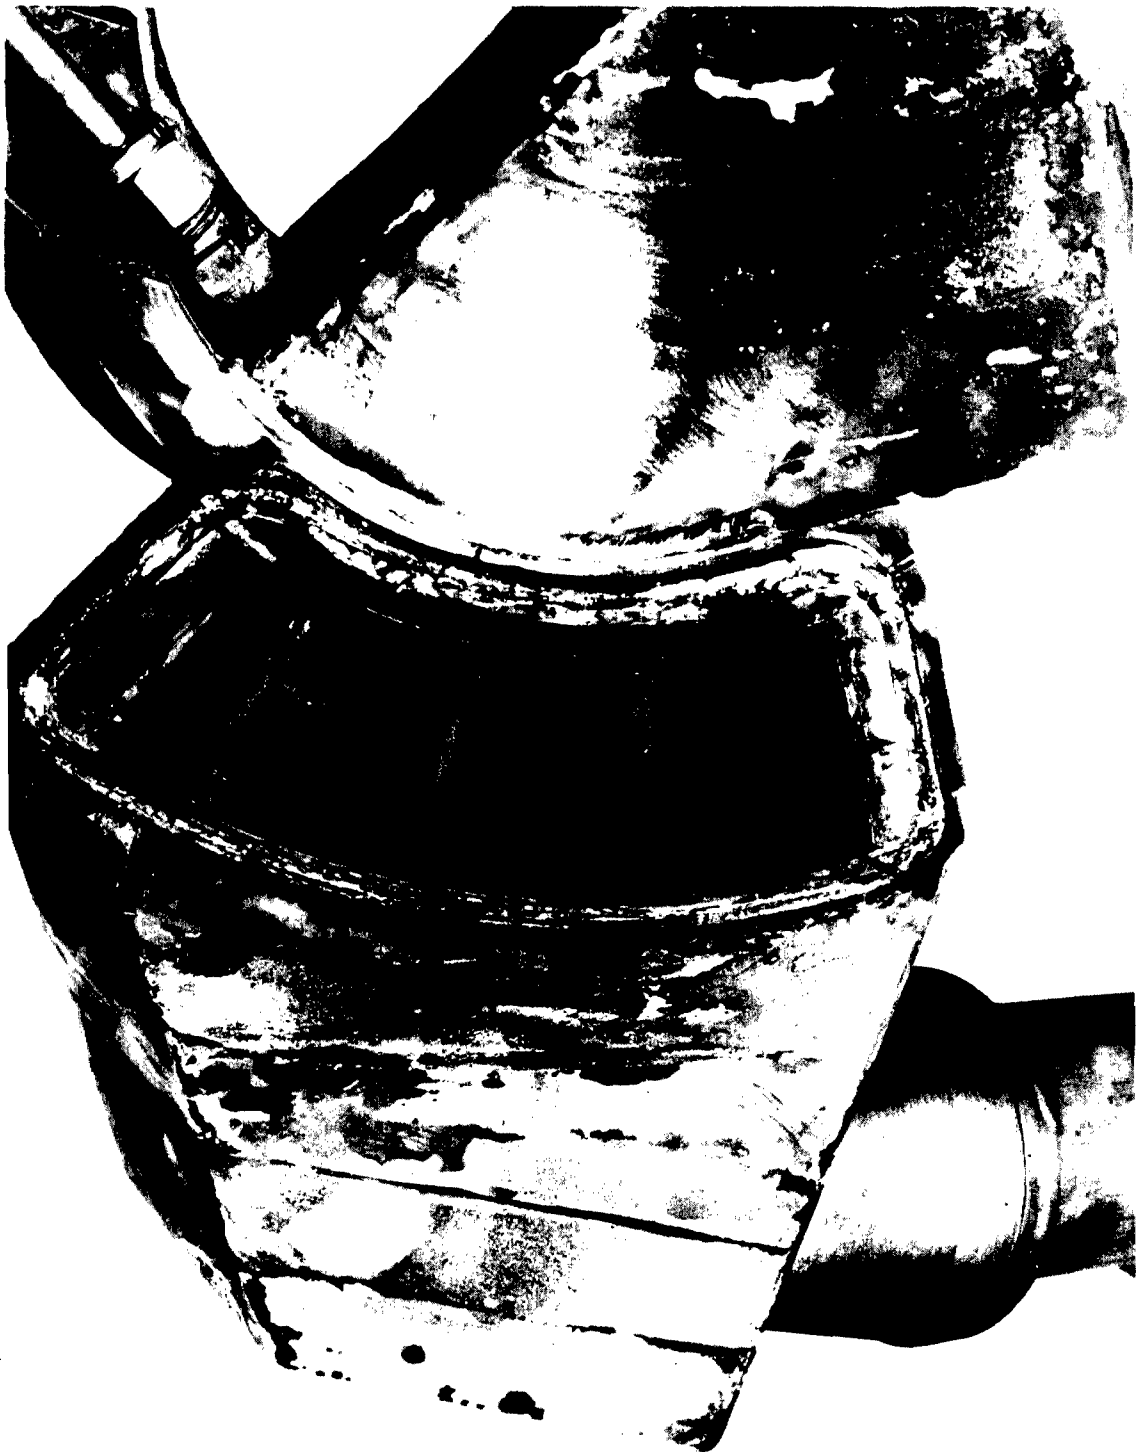
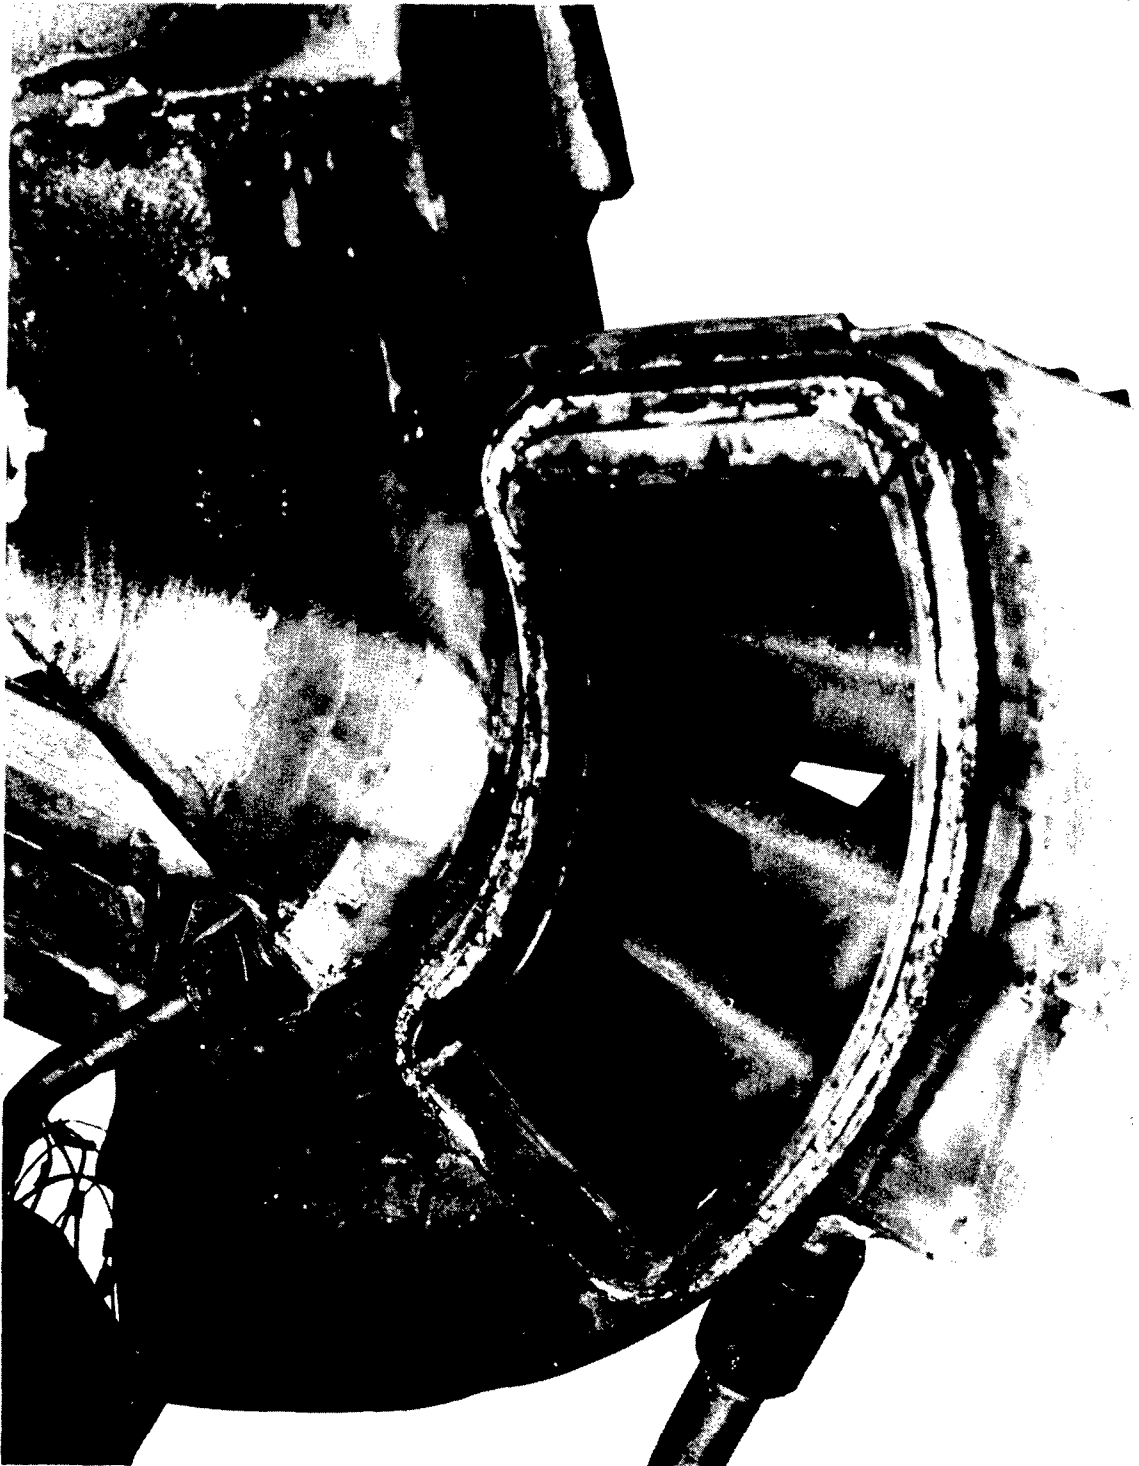
Figure 290. Turbine Inlet Nozzle Cascade After Test - View of Outer Shroud.

Figure 291. Turbine Inlet Nozzle Cascade After Test - View of Inner Shroud.

Discovery of the cracked vane-to-shroud joints opened a question as to the validity of the test data. Consequently, the test data were scrutinized for an indication of when the cracks had occurred and what effect, if any, they had on the test data.

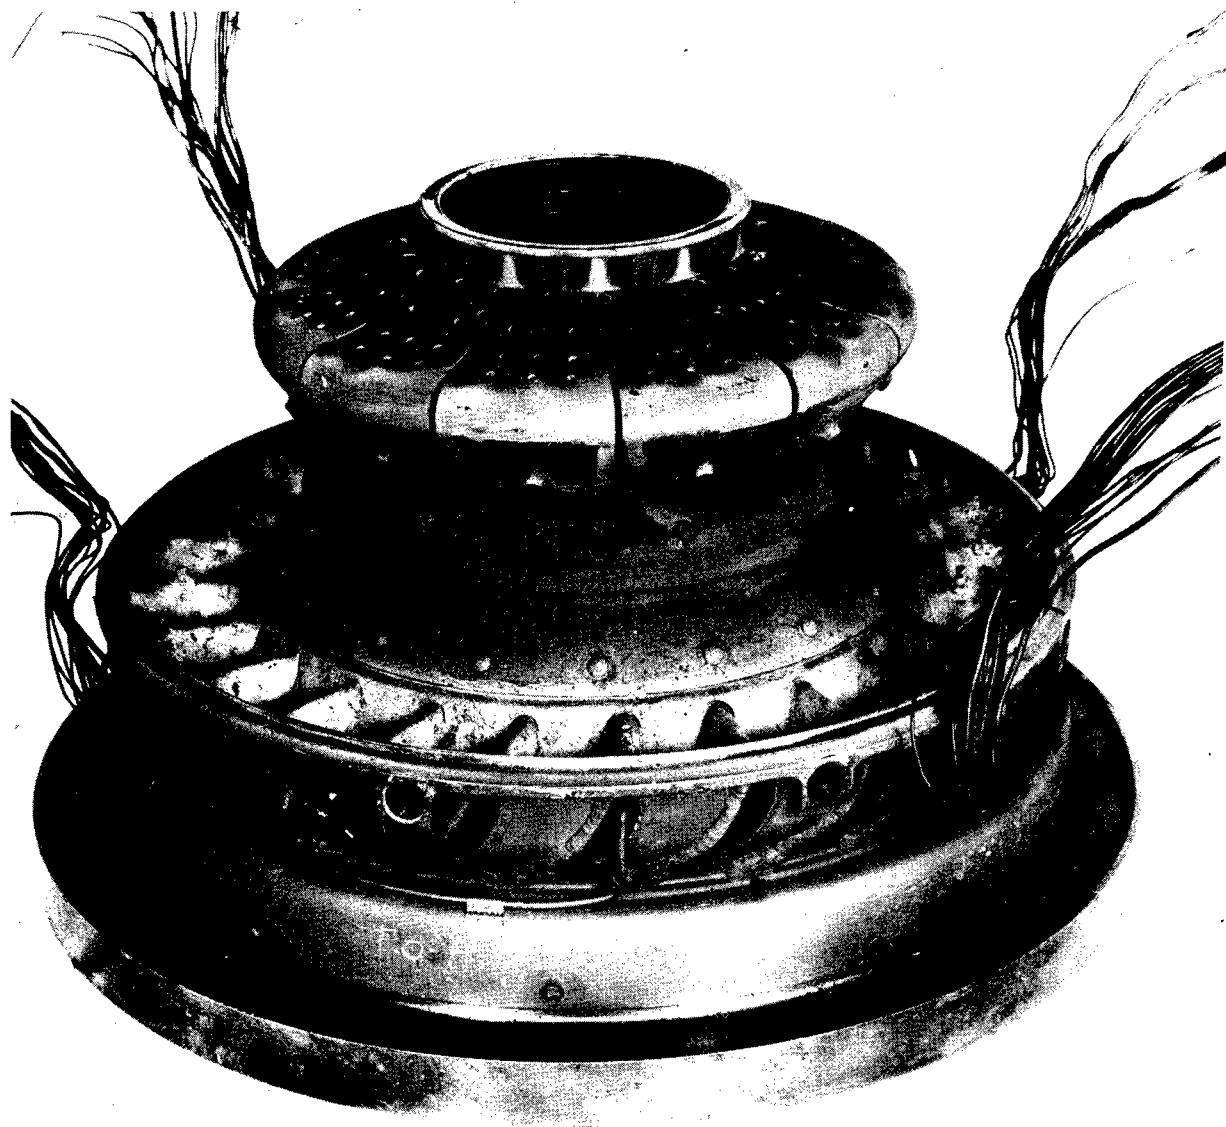
Figure 372. Inner Combustor and Turbine Inlet Nozzle Assembly at Completion of Build 7 Testing - Turbine Rig.

Figure 372 shows the inner combustor and turbine inlet nozzle assembly. The modification to the outer combustor labyrinth seal shroud mentioned above was expected to eliminate the slight carbon buildup which may be seen on the inner combustor shell. However, later testing indicated that this was not the case, and a slight carbon buildup was found at the conclusion of each test series.

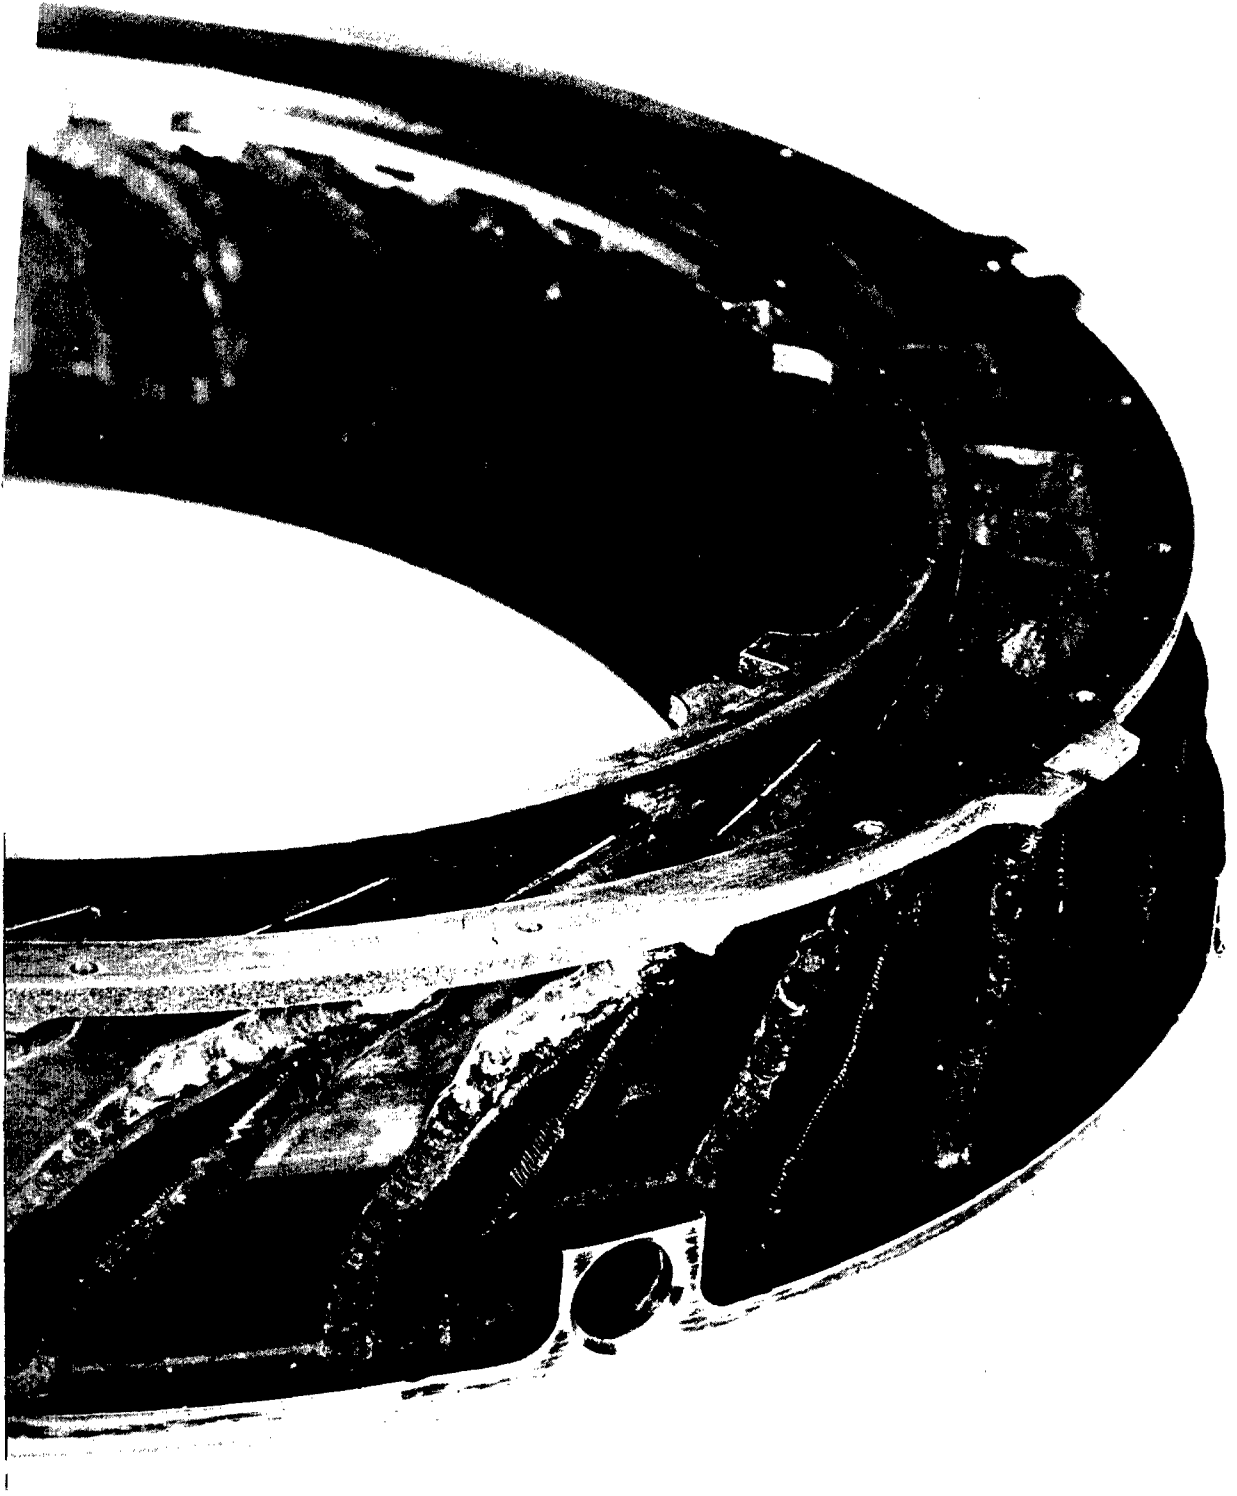
Figure 393. Interior Cooling Fins, Air-Cooled Nozzle.

This nozzle vane is identical to the vanes tested in the hot cascade rig with the exception of material and fabrication changes. These changes are tabulated below.
